October 13, 2011

Subject: DS Tributary (East) Work Plan Letter Report
Detrex Source Control Area – Fields Brook Superfund Site
Detrex Corporation, Ashtabula, Ohio
Docket No. V-W-98-C-450

Detrex Site – FBAG June 2011 Sampling Results DS Tributary (East)

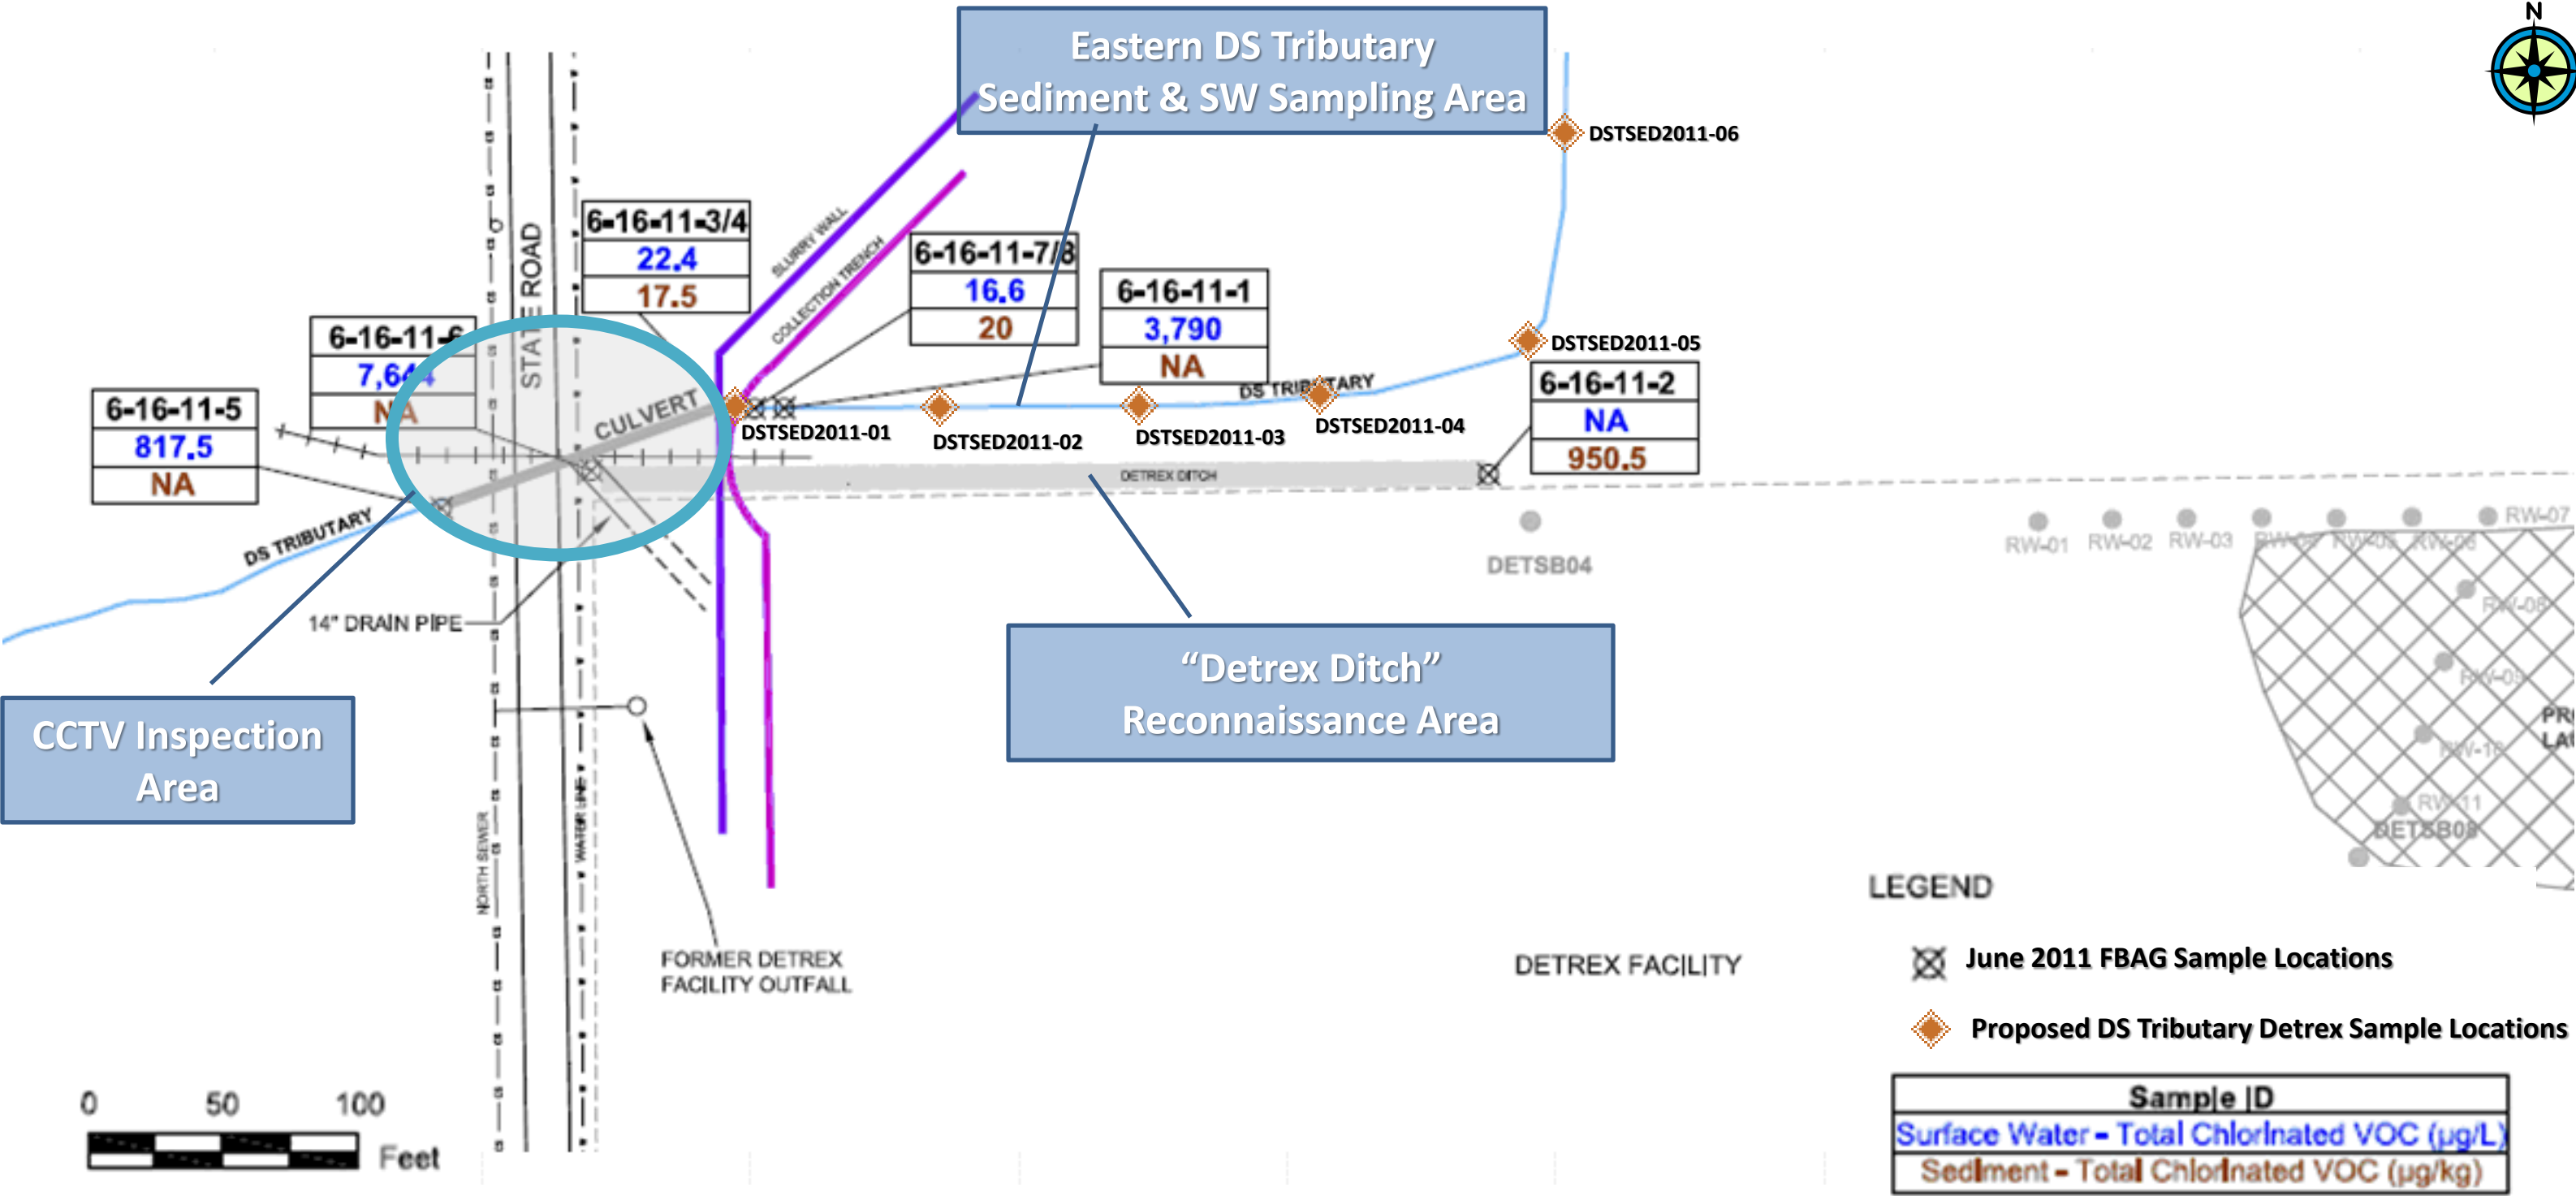
Figure 2

The proposed sampling locations for the eastern portion of the DS Tributary, as outlined in the Addendum, are provided in **Figure 2**.

Detrex Site – Proposed DS Tributary (East) Investigation Locations
